**US Army Corps  
of Engineers**  
Construction Engineering  
Research Laboratories

USACERL Technical Report 95/41  
September 1995

# **Ten-Year Summary and Final Report of Fort Irwin, CA, Family Housing Comparison Test: Operation and Maintenance Costs of Manufactured vs. Conventionally Built Units**

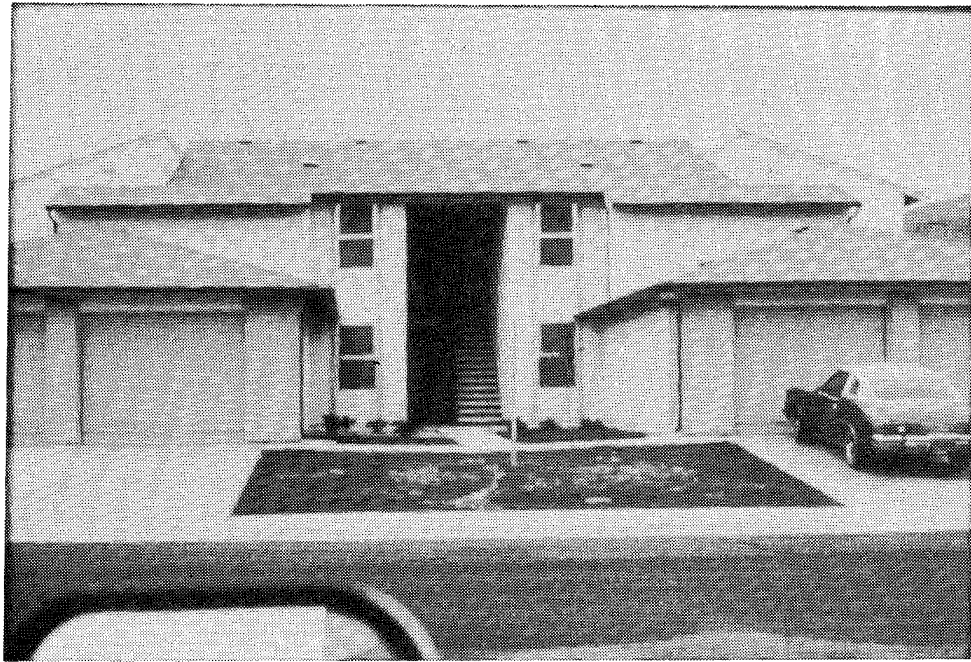
Front View - CBU

Rear View - CBU

**Figure 2. Front and rear views of typical CBUs.**

The 144 units consist of 13 sixplexes, 6 fiveplexes, and 9 fourplexes, all two-story buildings. Net floor area is 950 sq ft/unit and gross area averages 1120 sq ft/unit. These units were constructed on perimeter footings with building slab. Each unit has two bedrooms, a kitchen, living-dining area, one bathroom, utility room, either a fenced patio or balcony-porch (for upper unit), and a one-car garage. Figure 2 shows front and rear views of typical buildings. The fourplexes have two units on each level. There are two units on the second story in the five- and sixplexes with the additional unit(s) on the first level. The CBUs also have a refrigerator, gas range, gas water heater, garbage disposal, dishwasher, central air conditioning, and gas-fired forced-air furnace.
